CASE STUDY

PUMP REPAIR AND UPGRADE DELIVERS LONGTERM OPERATIONAL BENEFITS

CLYDEUNION®
PUMPS

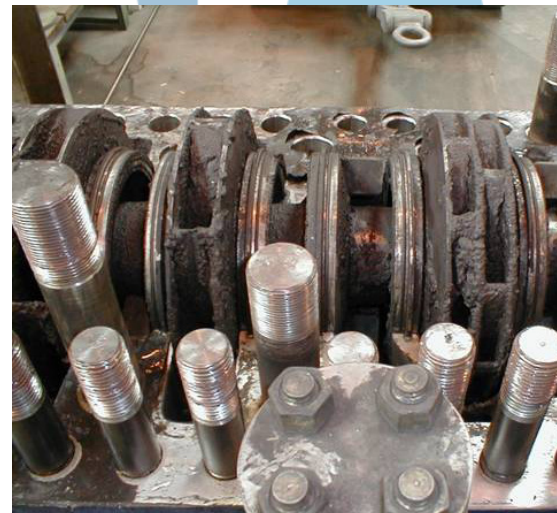
The function of the pumps is to water blast the scale off processed metal passing through the rolling mill. The water containing the pulverised scale goes to retention and decantation pools, then passes through a system of filters before being reused. Despite filtration, the recycled water still contains small particles of scale, which cause considerable damage to the inside of the pumps.

Erosion/scaling of pump parts

- Strip down and full dimensional inspection of parts
- Refurbishment of parts by weld deposition
- Reconditioning of threaded holes
- Heat treatment and re-machining of weld-repaired parts, including gasket faces
- Planing and re-boring of pump cases
- Cleaning of pipes and channels
- Re-assembly and hydrostatic test
- Clean down and paint

- Modifications to accommodate changes in clearances, redesign of parts and additional gasket
- Hard tungsten-chromium carbide coatings on central bearing bush, sleeve, piston and wear rings
- Hard tungsten carbide coatings on impeller necks and hubs.
