# SITE INVESTIGATION PUTS THE SPRING BACK INTO DOWNSTREAM OPERATIONS

Industry:	Oil & Gas - downstream
Region:	Americas
Category:	Site investigation
API Type:	Reciprocating pump

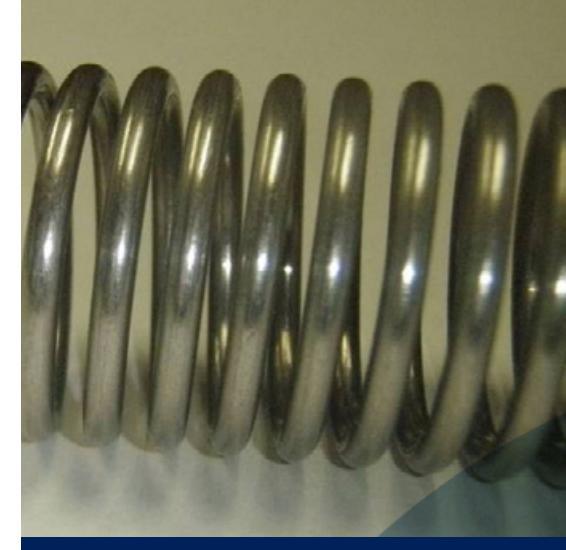
A reciprocating pump was causing unacceptable downtime issues for this downstream oil & gas operation. Frequent valve spring failures were resulting in a pump shut down every 2 to 3 weeks. The pump had been on the customer's "bad actor" list for some time due to the need for frequent maintenance and the associated costs.

The ClydeUnion Pumps Aftermarket Services team conducted a site investigation to determine the cause of the frequent valve spring failures. Springs were analysed for the type of failure, repeatability of failure, and conclusions drawn regarding the cause. Analysis revealed that a fatigue failure was occurring in an area of the spring where the pitch was changed to close and grind the ends during manufacture. Surface defects in this area were produced during this pitch change, resulting in stress risers that led to a fatigue failure.

Solving the defect was reasonably straightforward. The existing valve spring design, material and manufacturing process was unchanged - with the exception that the completed valve

springs were shot peened. This additional process mitigated the stress concentration at the surface of the spring wire produced during manufacture. Upgraded valve springs were installed at the site and there have been no spring failures reported to date.
