CASE STUDY

PUMP REPAIR AND UPGRADE DELIVERS LONGTERM OPERATIONAL BENEFITS

CLYDEUNION®
PUMPS

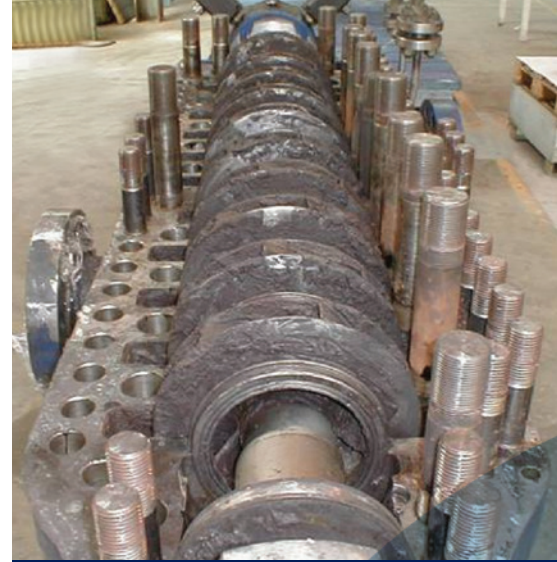
The function of the pumps is to water blast the scale off processed metal passing through the rolling mill. The water containing the pulverised scale goes to retention and decantation pools, then passes through a system of filters before being reused. Despite filtration, the recycled water still contains small particles of scale, which cause considerable damage to the inside of the pumps.
