## CASE STUDY

# NEW HYDRAULICALLY UPGRADED PUMP CARTRIDGES DRAMATICALLY REDUCES DOWNTIME

**Category:** Hydraulic re-rate

**API Type:** BB5

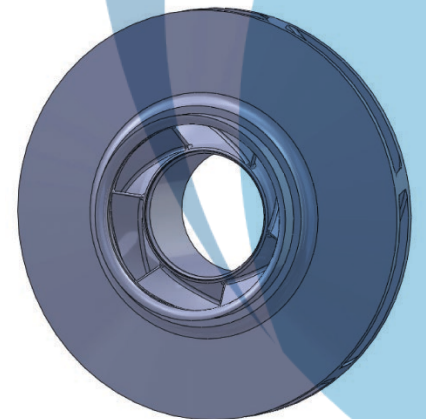
## DUTY COMPARISON BETWEEN THE ORIGINAL PUMPSET AND PROPOSED UPGRADE:

CURRENT	PROPOSED	% CHANGE
Speed	2969 rpm	2969 rpm	0 %
Head	2196 m	2270 m	+ 3.37%
Flow	420 m <sup>3</sup> /hr	450 m <sup>3</sup> /hr	+ 7.14 %
Power	3787 kW	4080 kW	+ 7.74 %
Head (Closed Valve)	2455 m	2609 m	+ 6.27 %

To minimize impacts on customer operations, ClydeUnion Pumps replaced the entire cartridge, rather than just the impeller. The new pump cartridges were designed, manufactured and assembled at our site in Glasgow, Scotland and included the increased diameter impellers and high-efficiency diffusers to meet increased capacity, the ring sections (designed to fit in the existing barrel), as well as the shaft, balance drum, end covers, bearings and seals. This approach enabled the hydraulic re-rate to be performed in a much shorter timescale with minimum downtime and eliminated the need to replace wearing parts on-site. It also enabled dynamic balancing of the rotating element for these nine-stage pumps to be performed under factory conditions.
